PORIYAALAR

ஏப்ரல் 2026
April 2026

A case study of distress analysis in Anaikuttam dam and possible remedial measures

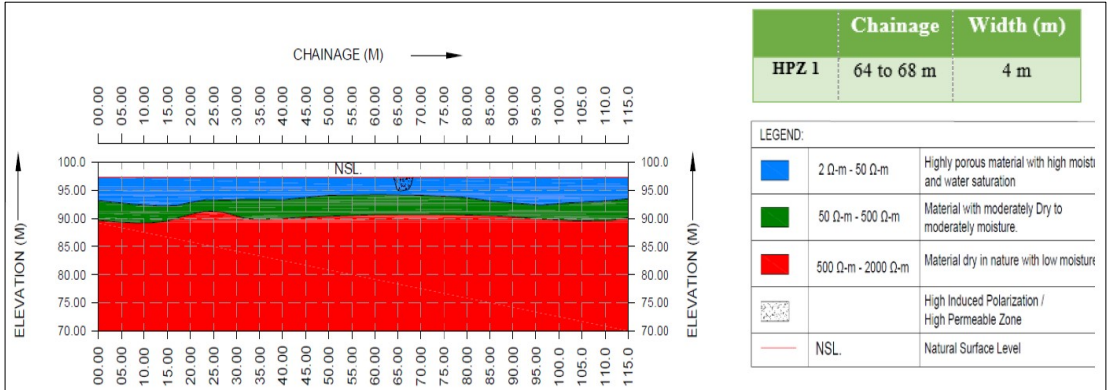
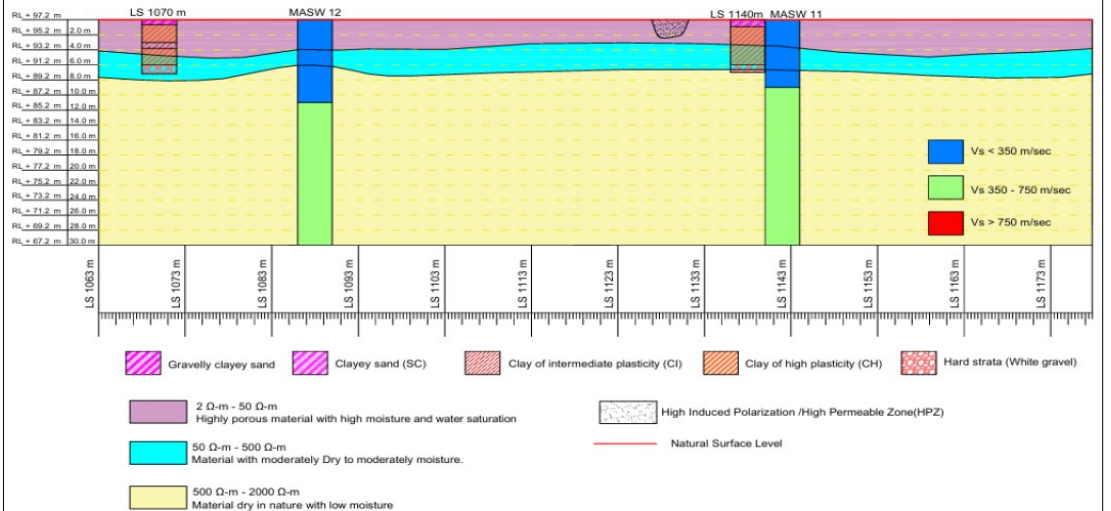
Left Embankment - Figure No.18

Combined analysis of geotechnical and geophysical carried out on the left embankment at Anaikuttam dam

4. The geophysical investigation (Fig. 18. Refer page No.20) substantiates the presence of weaker zones up to a depth of 11m from the crest of the bund. This weak zone stretch is extending for a length of 115 m from the left abutment since the shear wave velocity of the strata is less than 350m/sec.

5. Further, highly polarized pockets (high permeable zones HPZ) are also observed within this weak zone.
